# Safety

A Corporate Safety Publication

May - June 2009

# Midair over the Amazon

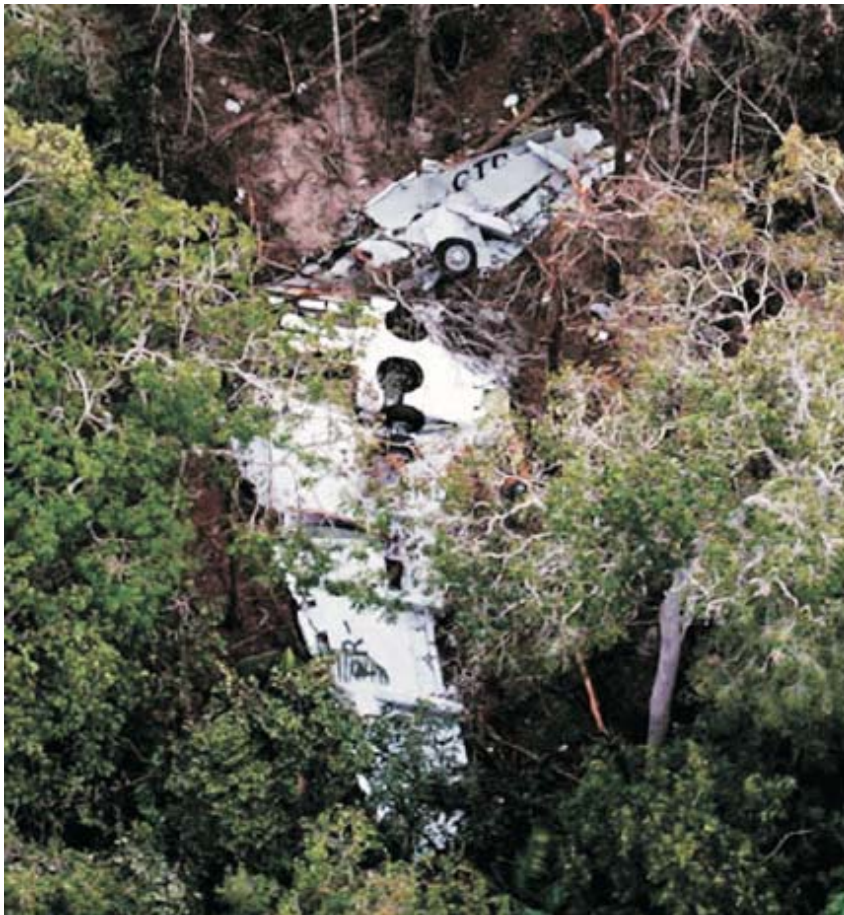
All 154 people aboard the 737 were killed when the airplane broke up during descent and crashed in the rain forest.

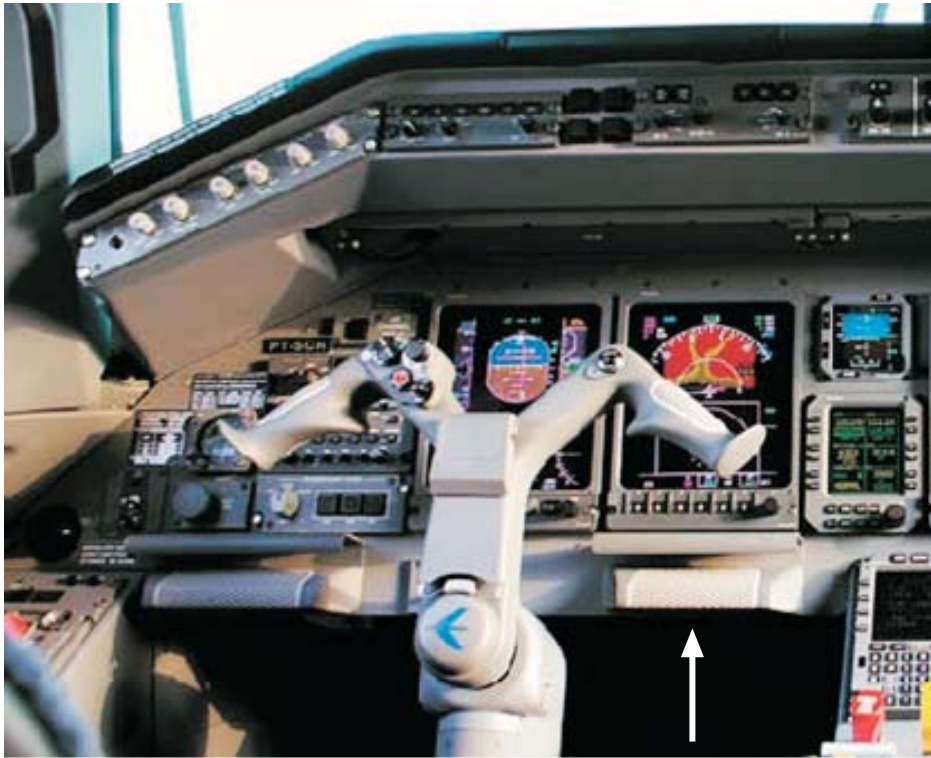
Another possibility is that the button was accidentally struck when the pilot placed a foot on the footrest at the bottom of the panel. However, “the footrest has a metal plate, called a foot protector, designed to keep the foot away from delicate instruments which could be damaged if contacted inadvertently,” the report said.

Brazilian investigators considered the possibility that the Legacy's transponder might have been deactivated when the captain's foot, when placed on the footrest shown by the arrow, inadvertently touched the radio management unit above and to the right of the footrest.
