A Corporate Safety Publication

Pakistan International Airlines
A Corporate Safety & QA Publication

Vol. 42

September-October 2008

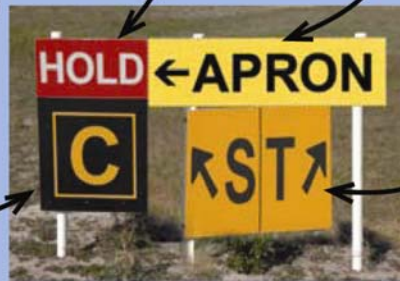
Identifies the taxiway you are located on.

Black square: you're there

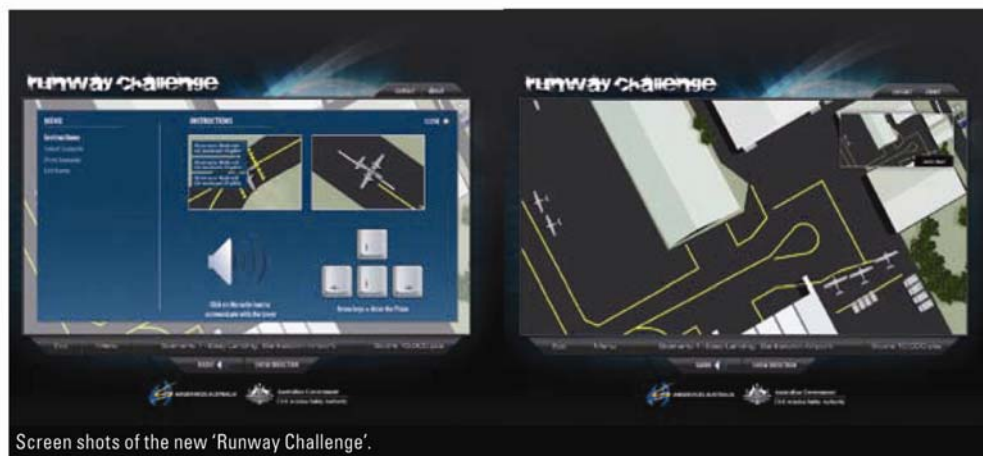
Screen shots of the new 'Runway Challenge'.

aerodrome, where they will be faced with a number of pre-set, real-life scenarios. 'Pilots' can select different levels: 'easy', 'medium' and 'hard', which will then determine the number and type of scenarios they face as they manoeuvre around the aerodrome. For each level, pilots can only lose a specified number of points before they fail – with some dangerous or illegal practices resulting in automatic failure.

The Challenge requires the correct phraseology to be used; if you choose the incorrect option, you'll immediately lose 100 points, thereby reinforcing the importance of standard phraseology for effective communication. It will also reinforce a broader understanding of correct taxiway and runway procedures because at the end of each scenario, pilots will be shown 'Here's what you did wrong'. They can then re-do the scenario to get a perfect score, and then level 2 will open up. Pilots will also be able to print out the scenario detailing all the correct phraseology, which it is hoped will benefit student pilots of non-English-speaking background. ■

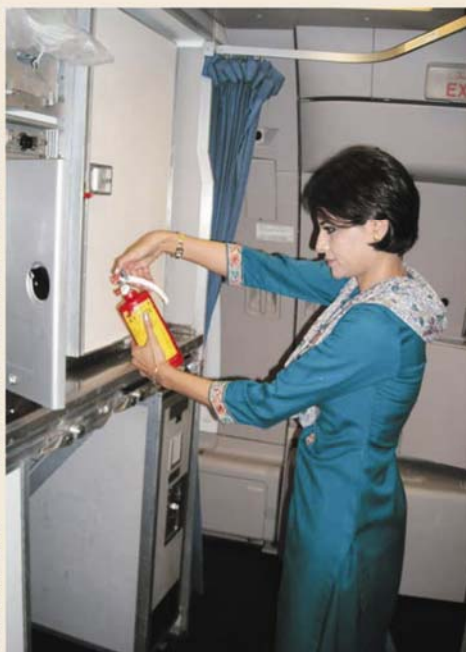
Figure 1

Familiarity with the hidden areas where fire might occur on a specific aircraft type (Figure 1) enables cabin crew to accurately describe the emergency to crewmembers who are on the flight deck or in other areas of the cabin. For example, the cheek area of narrow-body aircraft and wide-body aircraft typically contains wire bundles, hydraulic lines and other electrical components. An overhead area typically contains components of the aircraft's entertainment system, wire bundles, control-surface cables, portions of the air conditioning system, the passenger emergency oxygen system and other systems.
